Site 1. Glenfern Road Woodland, Upper Ferntree Gully

This document provides a detailed assessment of the current conditions of Ferry Creek Reserve and its surroundings, including the topography, scenery, vegetation, wildlife, flooding dynamics, erosion and other management needs. It also investigates opportunities and constraints for the reserve's future. These lead to the conceptual landscape plan itself in Chapter 4.

1.1 Purpose and Goals

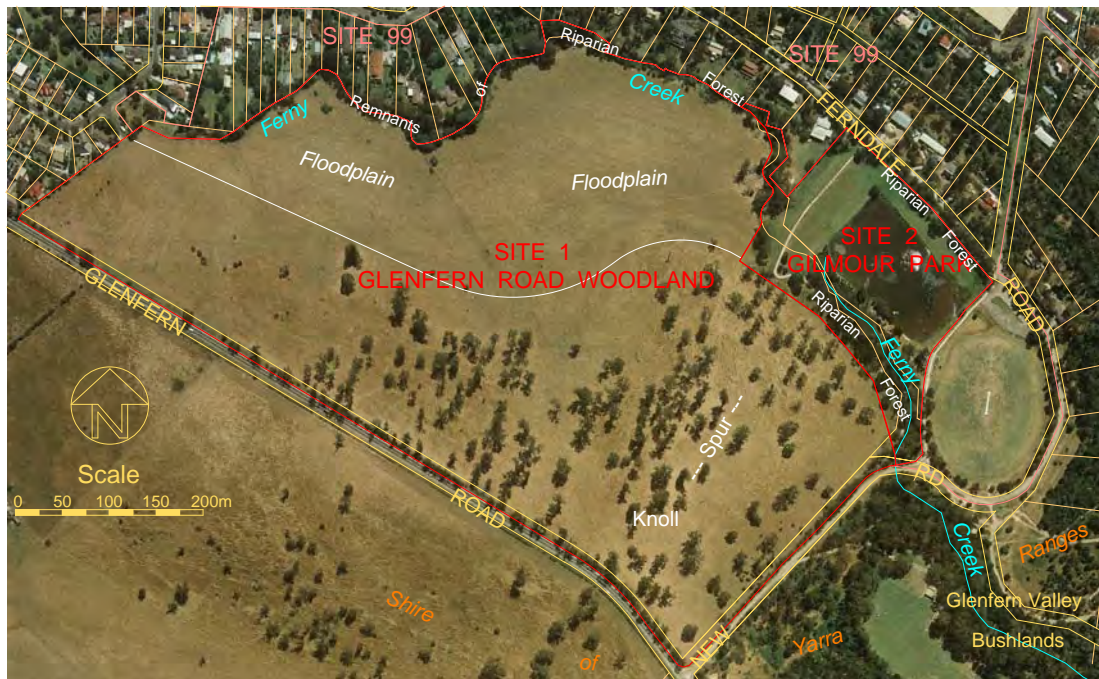
Aerial photograph taken February 2001

This site comprises 157 Glenfern Rd and the abutting road verges, as outlined in red and labelled ‘Glenfern Road Woodland’ above. The wavy part of the boundary follows either the creek or an adjacent fence. Site 2 can be seen abutting to the northeast, and part of Site 99 to the north.

The Knox Planning Scheme maps show a more complicated boundary between 157 Glenfern Rd and Gilmour Park than that shown above. The former does not accurately reflect the reality that there is a fence along the red line shown above, which divides the land between private grazing and public park management.

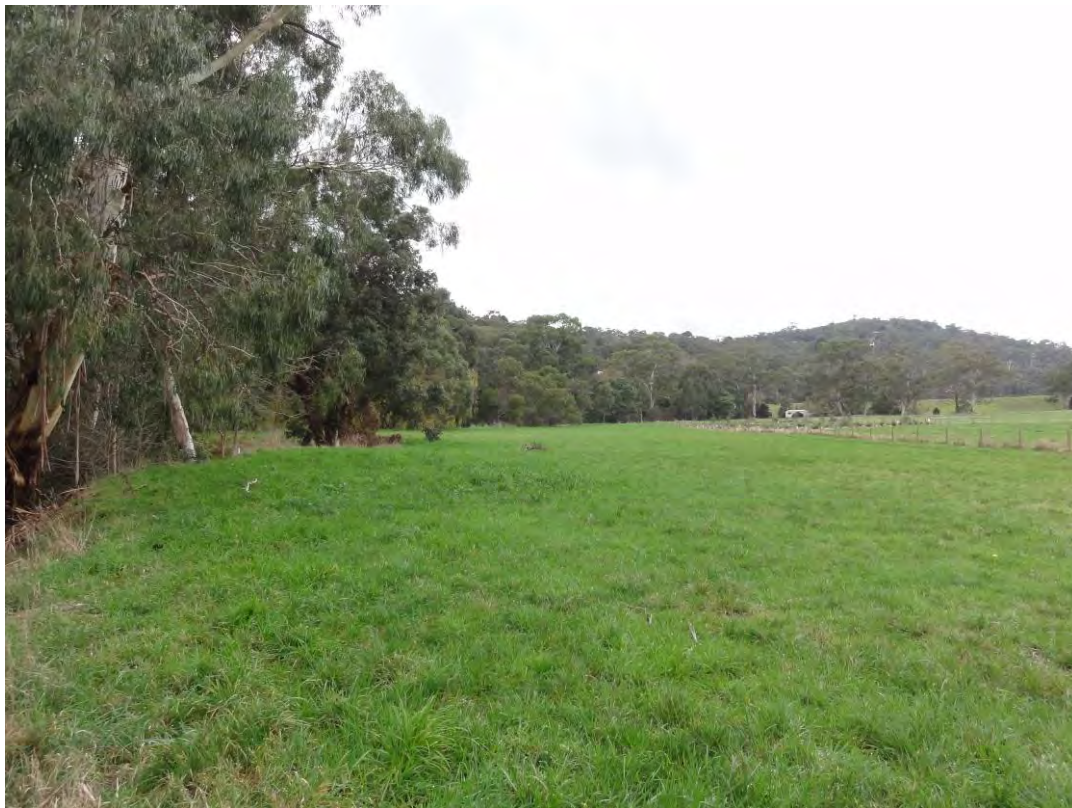
Figure 4. A representative view of the floodplain, flanked by trees along the lip of the creek channel at left and private land over the fence at right. The retarding basin levee can be seen in the distance at right.

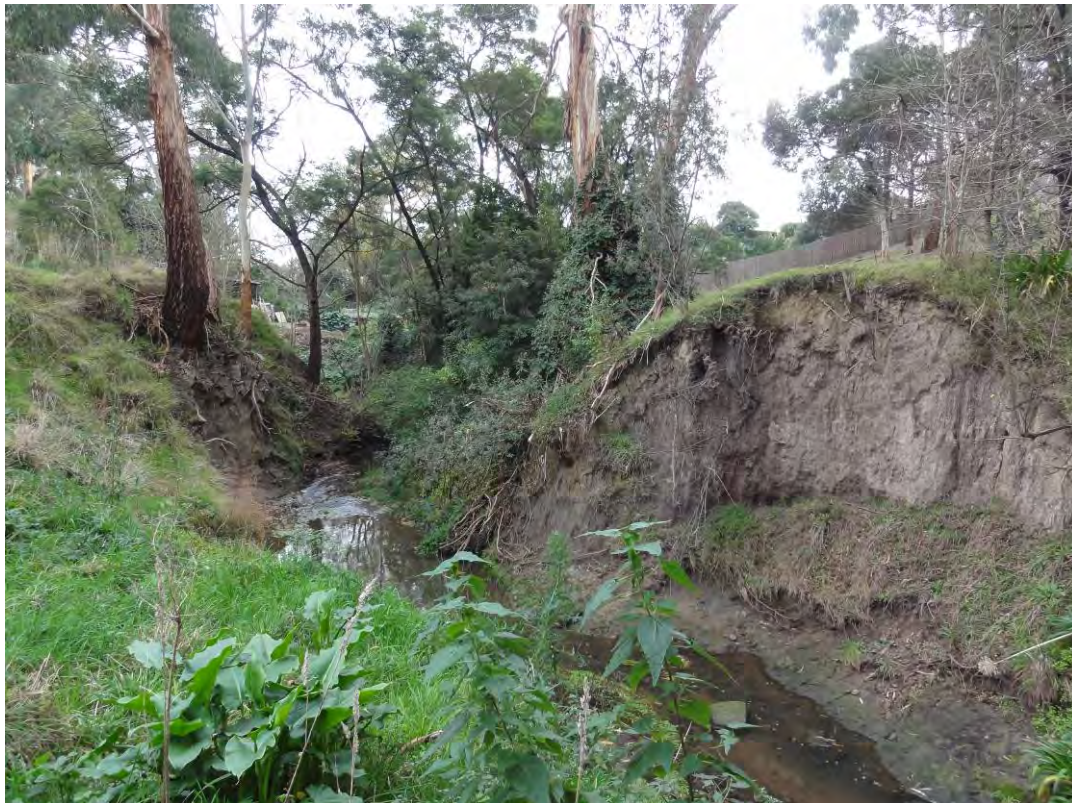
Figure 6. A representative scene within the creek channel, showing the water, an inclined bank apparently created by heavy machinery (bottom left) and steep, eroding banks with variable vegetation.

The creek channel raises the most pressing and complex management needs in Ferry Creek Reserve. Its depth varies from 1.5 m amid willows in the west to 5 m near its most northerly point. It has clearly defined lips and sides that are mostly steep except at several locations where cattle or heavy machinery have accessed the creek, as seen in Figure 6.

Banks that are collapsing, such as those in Figures 6 and 7, are called ‘cut banks’. Cut banks occur naturally but are unnaturally prevalent in Ferry Creek Reserve. They are a safety hazard for people, a source of excessive sediment in floodwater and a challenge for revegetation. On the right bank (where private land abuts), bank instability is also reducing the usable land and posing a risk of undercutting at least one house.

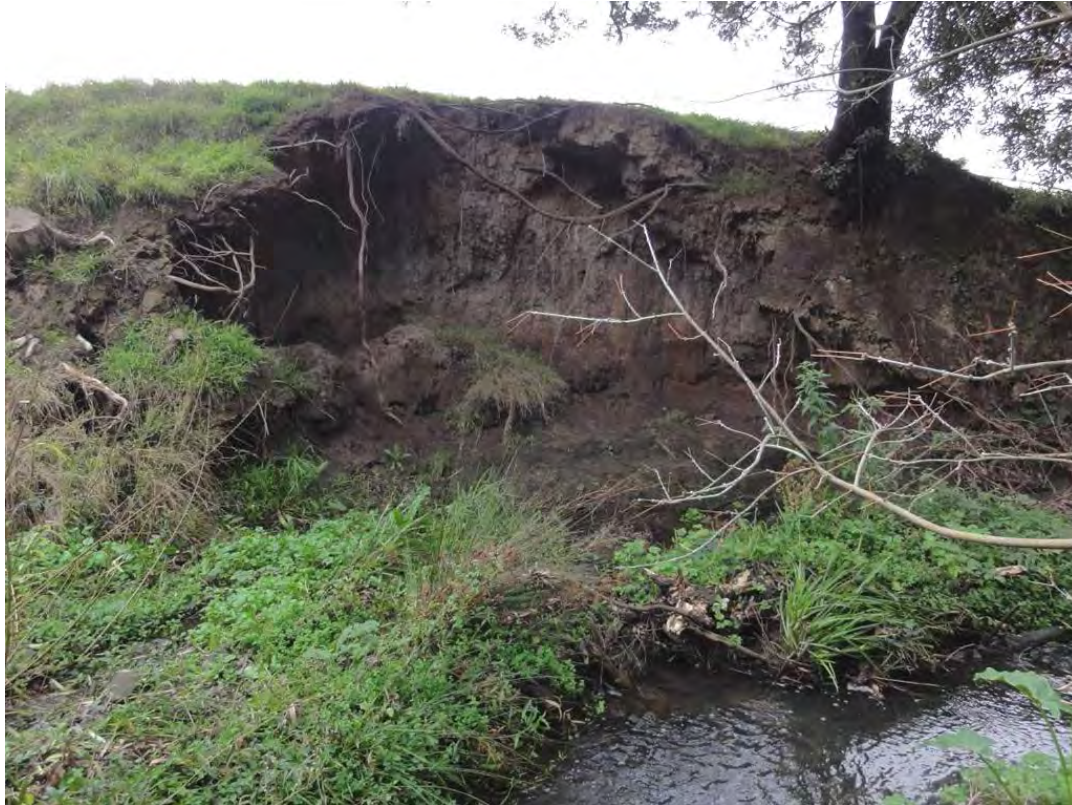
Figure 7. A dangerously undercut bank.

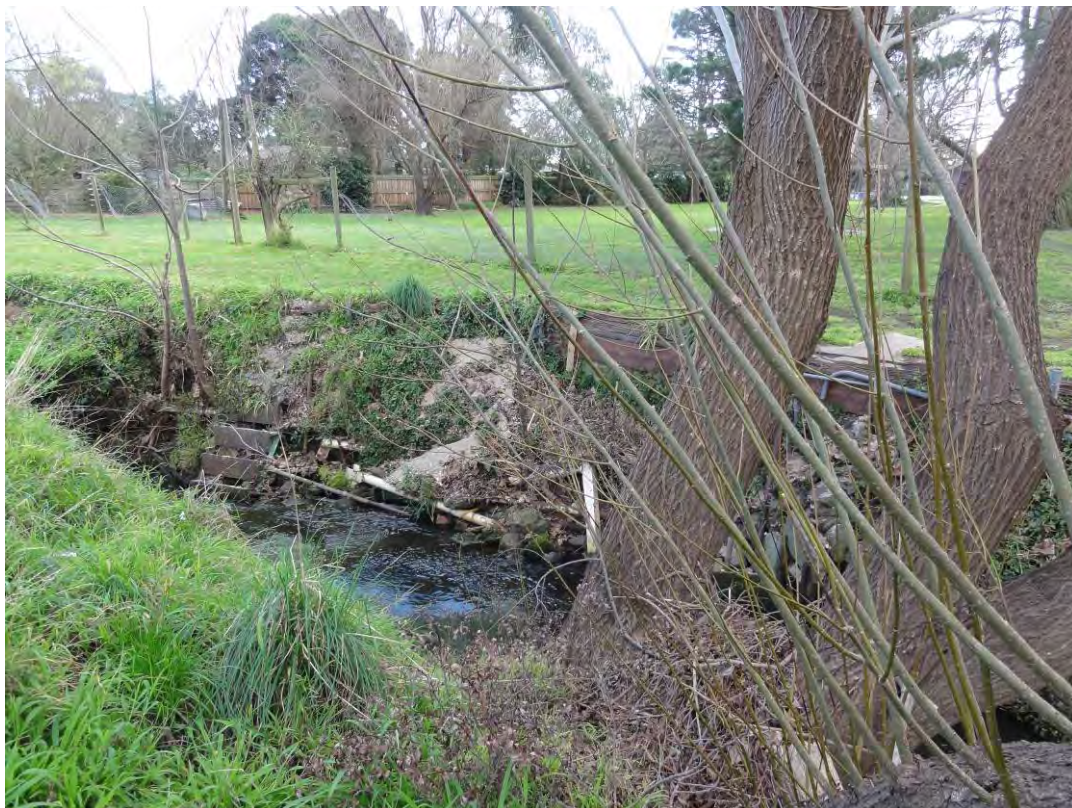
Figure 8. Scouring of the creek bank by water that must divert around a willow trunk and then accelerate in its descent from the mound of the root mat.

Interestingly, indigenous trees tend to grow at the top of creek banks but rarely in channels, and never with root mats like willows. The natural courses and channels of local streams have evolved in response to indigenous vegetation and are destabilised by trees that interact differently with stream flows.
